LANCASTER FM159 FLOOR RESTORATION

NOV 2014-JUNE 2016

By Dr. Brian J. Taylor DVM

PART 1 INVESTIGATION

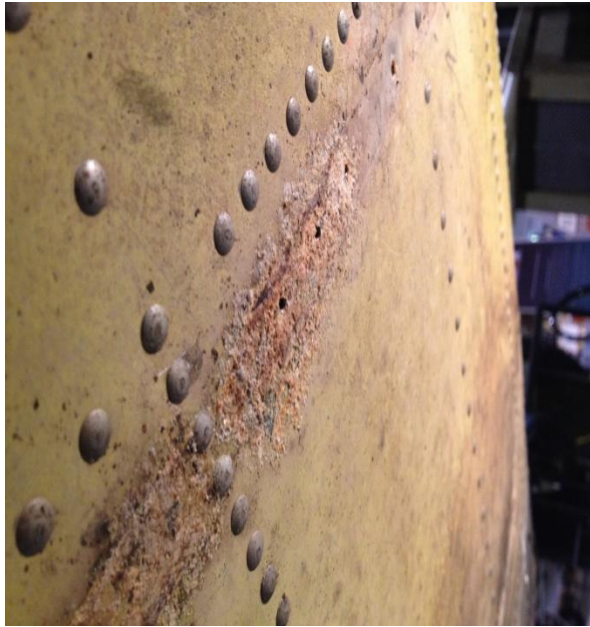
This project originated as a plan to remove the wooden walkway and fill in the opening in the floor where the H2S radar was located. The floor panels were removed in this area by grinding off each rivet. Once these panels were removed it revealed extensive corrosion in the location of the post war Elsan. This subsequently lead to the removal of the three outer fairing panels located immediately aft of the bomb bay. This then revealed a wooden lattice support structure that had badly rotted. A decision was made at this point to restore the rest of the floor back to the horizontal stabilizer.

Skin corrosion under fairing

Our woodworking expert Terry Moynihan took on the arduous task of making a new wood lattice support structure for the bomb bay fairing. This piece had to be laminated and curved to match the compound curvature of the underside of the Lancaster fuselage. He did such a superb job that he was requested to make two more for the British Lancasters NX611 "Just Jane" and BBMF PA474.

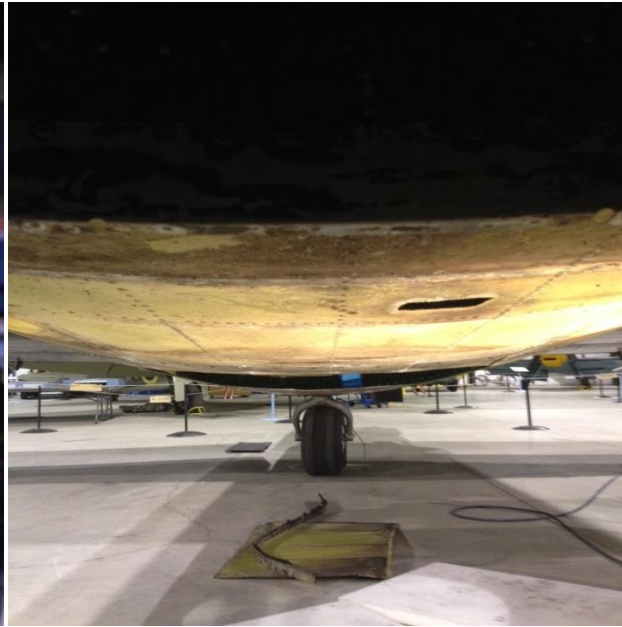
Skin corrosion

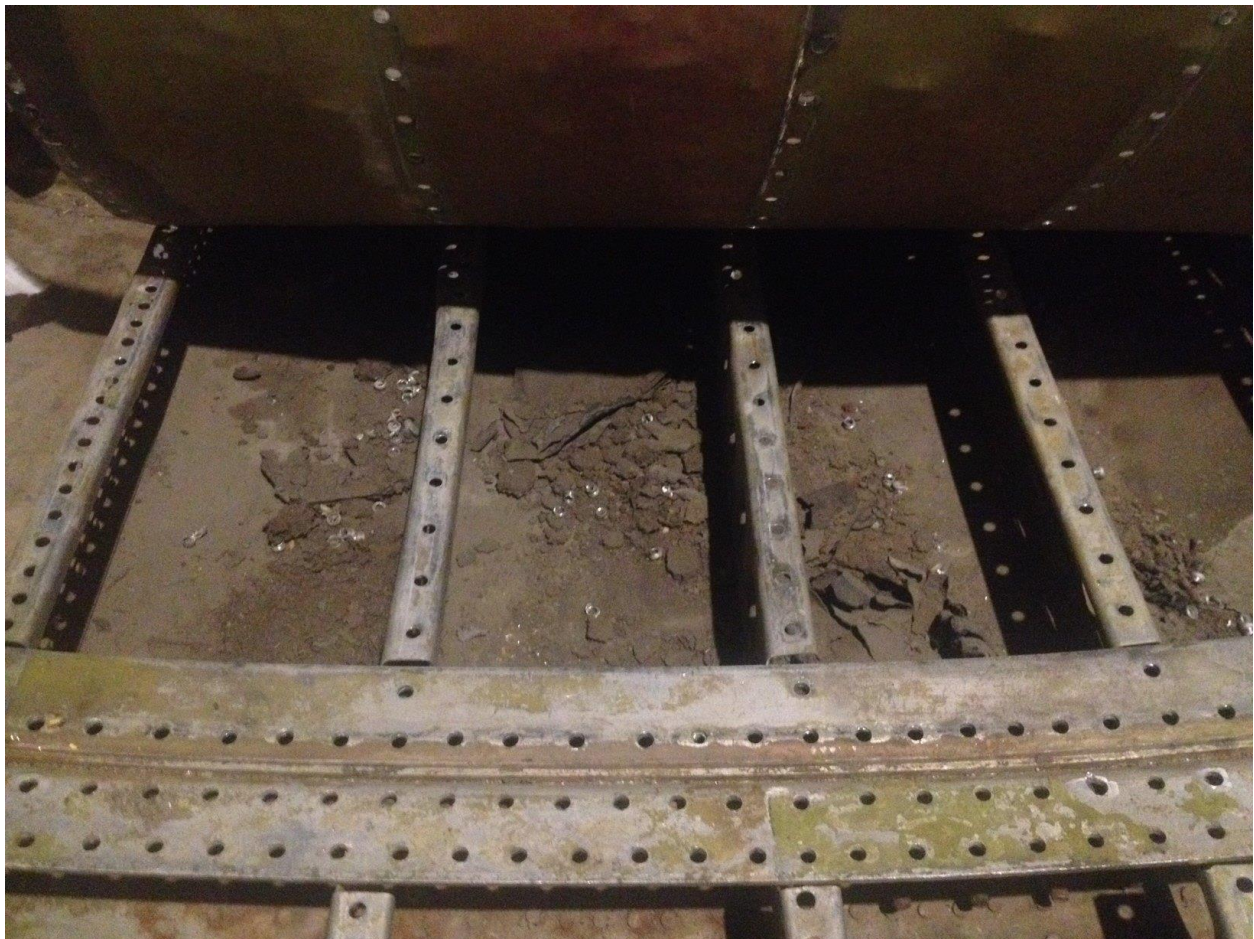
After removing all of the floor panels it revealed extensive debris and superficial corrosion. All of the support structure under the floor was then cleaned with scotch brite pads and dental picks to get into every crevice. The downward identification lamps and wire harness were removed at this time for restoration.

Debris and corrosion under old floor panel

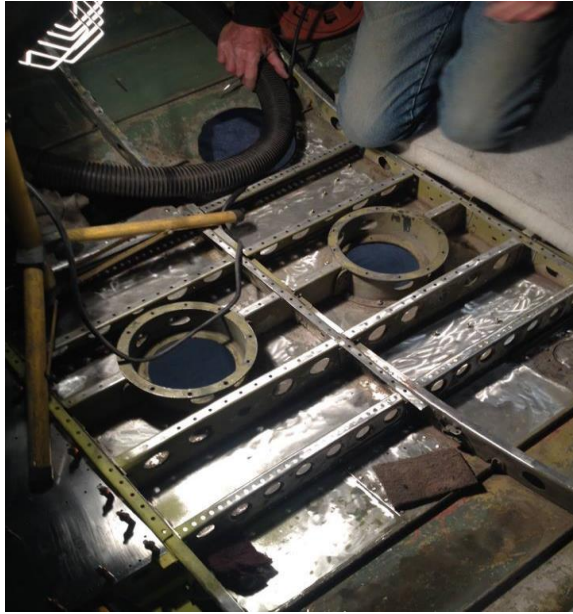
Cleaning mid floor section

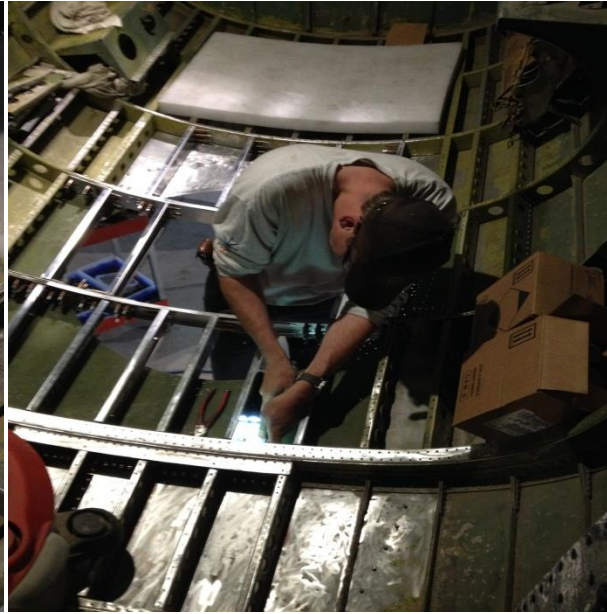
Greg fitting intercostals

At this point the project split into two components. Greg Morrison began fitting the new formers and intercostals. Each piece had to be hand fitted and trimmed to fit. New connecting brackets had to be made for each end of the new pieces. These were then cleco clamped together to ensure proper fit. The whole structure was then taken apart to be primed and have lightening holes made by Dan Hawken. Once all the pieces were ready Greg then riveted them in place and installed floor shims where needed.

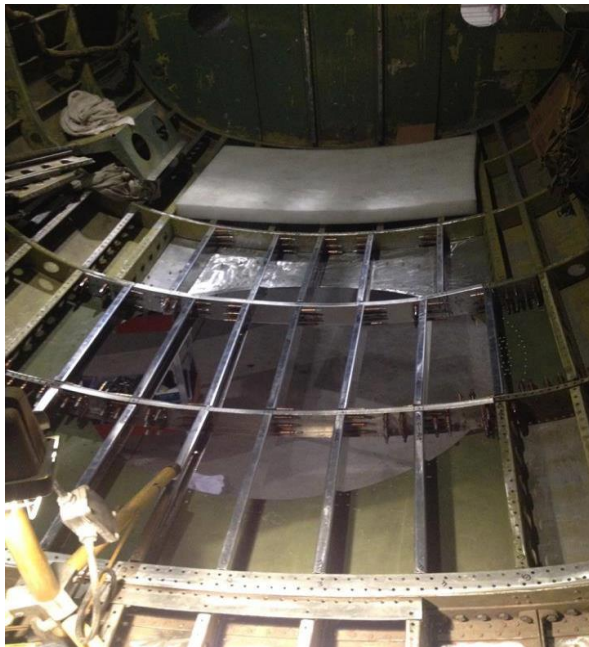
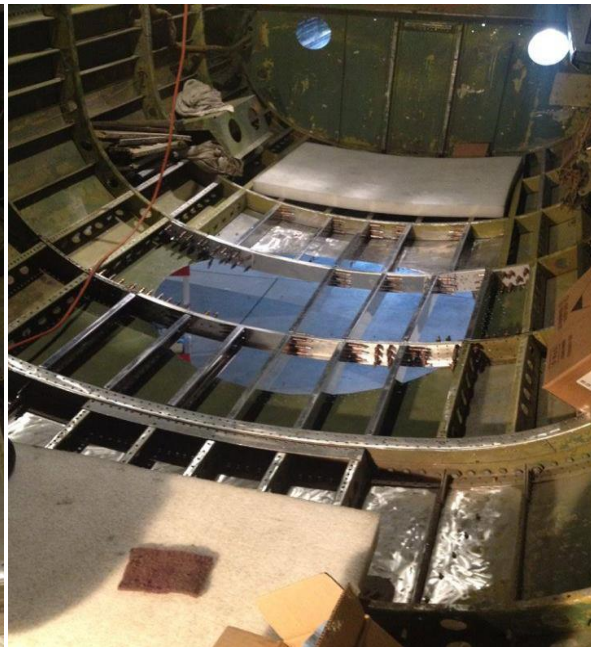
New pieces cleco clamped

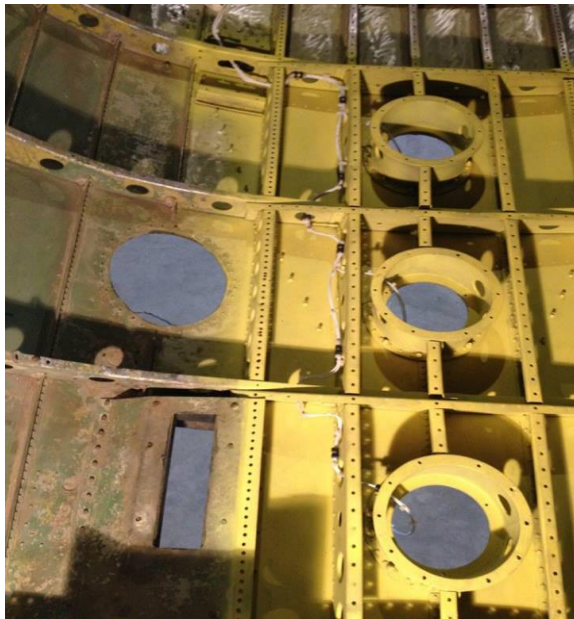
Floor primed

The whole floor area was then primed with zinc phosphate as were the parts to be installed. At this point we decided to move the Elsan (chemical toilet) further aft to its war time location just ahead of the horizontal stabilizer. On this floor panel rivnuts were installed ahead of time to allow us to secure the toilet to the floor later on.

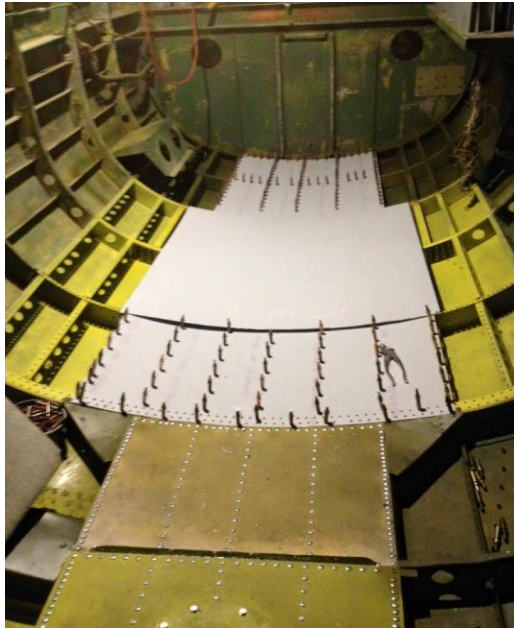
Back drilling new panels

My task was to copy each floor panel that was removed and fabricate new ones. Each old piece was used as a template by cleco clamping it down over a new sheet of aluminum. Every rivet hole was drilled and then the parts were cut and trimmed to exact size. All of the rivet holes and sheet edges were then deburred from both sides. The centre floor area was covered with 0.040" aluminum and the outer floor pieces and the fairing was made from 0.032" aluminum. A total of 14 parts were made. The new floor over the H2S opening had to be made by back drilling through the new formers and intercostals. A large circular part was made for the outer skin covering the H2S opening.

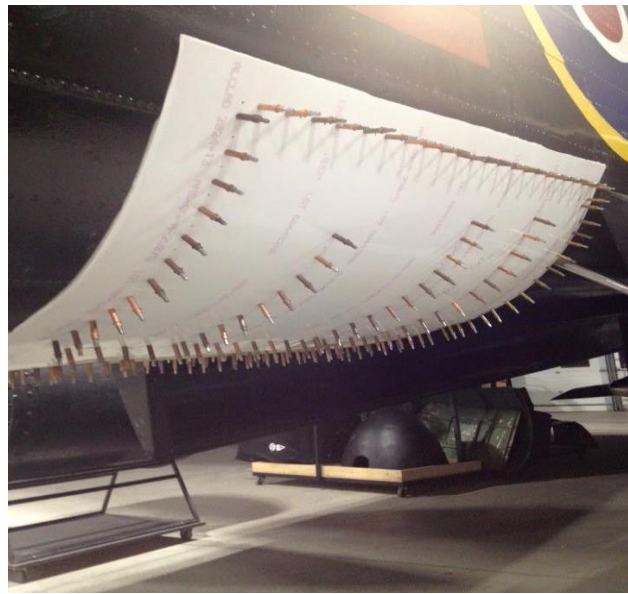
Building fairing

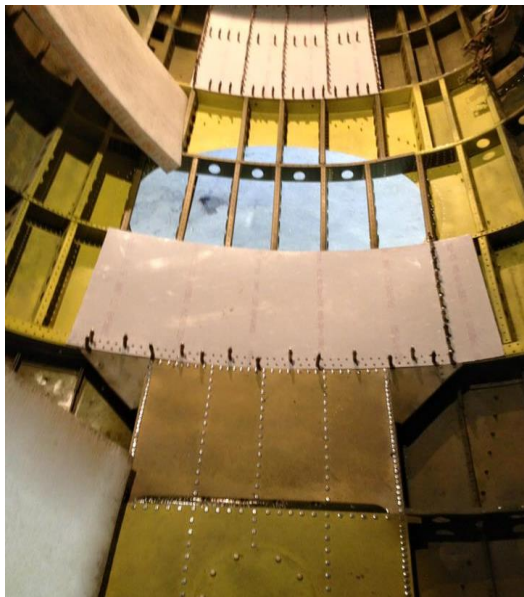
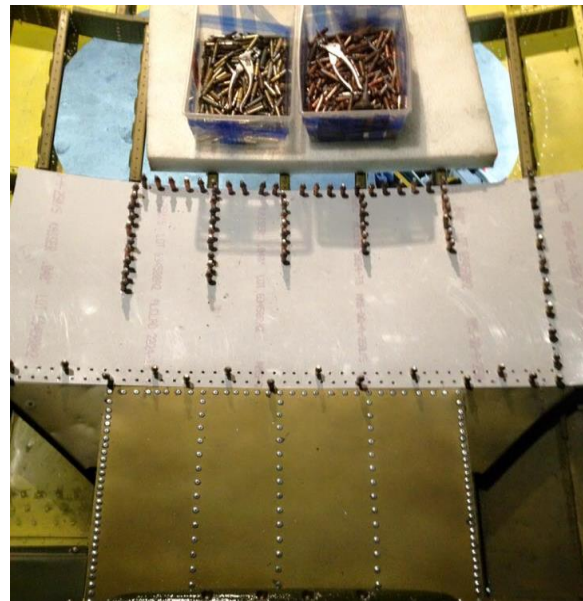
Rough fitting of floor panels

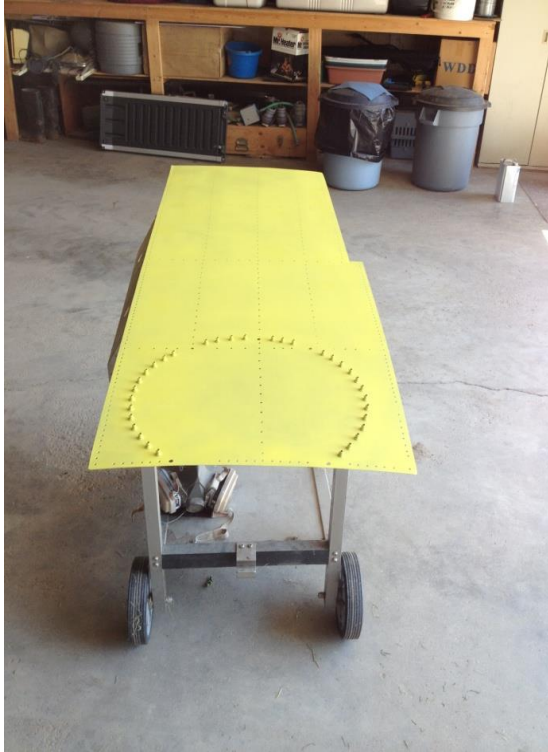
Aft floor panel showing rivnuts for Elsan

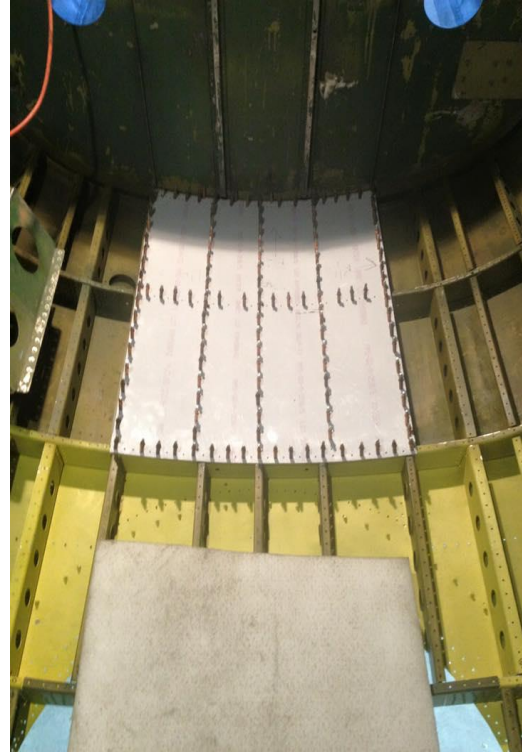
Forward panel up against bombay

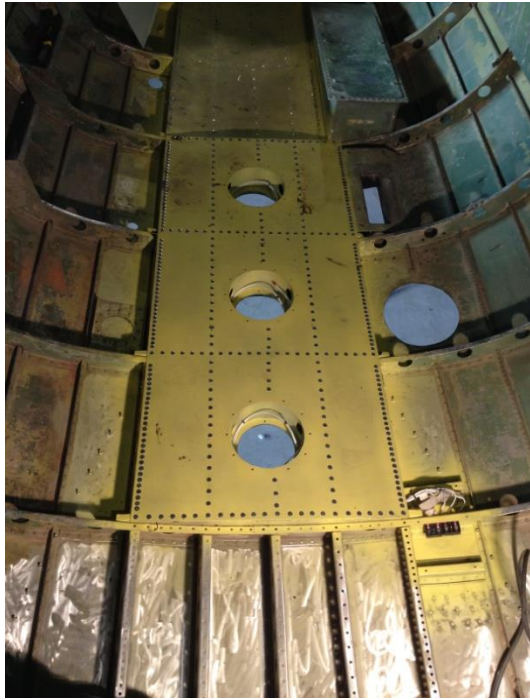
IFF floor panel installed

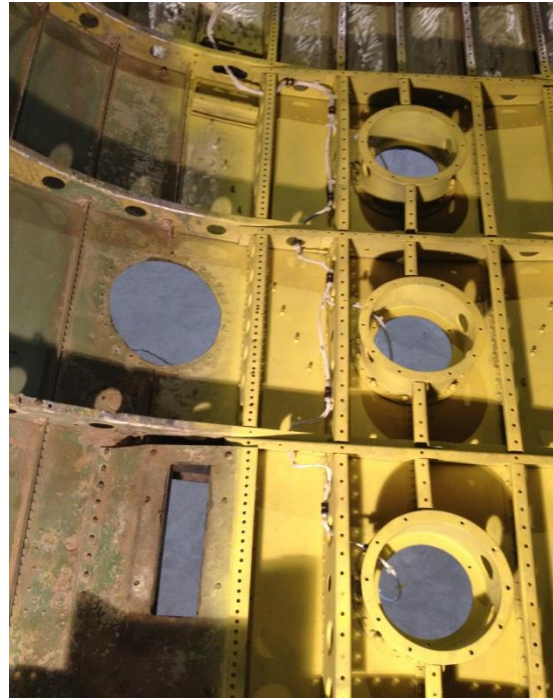
Since the floor was being removed a decision was made to make the downward identification lamps operational. The old wiring and some of the fixtures were badly corroded. Greg made up a new wire harness from the lights to JB9 (junction box). I managed to rebuild the lights using parts available from the museum. I installed the new wire harness and fixtures and then began the arduous task of tracing the wiring through the whole aircraft forward to the main distribution panel. New connections were made in the panel at breaker No5. From here, wires were traced forward to the pilot's panel light switches and Morse Code switch. This was a major task that involved checking many circuits to establish continuity.

IFF wire harness in place

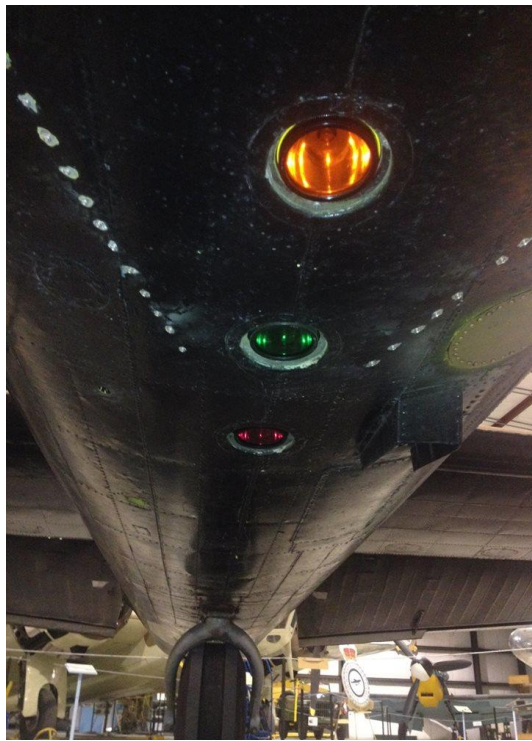
IFF lights in place

I was able to source a supply of light bulbs from England that had the correct configuration to fit the receptacles. They even worked! Shane Chipchase was able to cut coloured glass lenses to fit in the lamps-red, green and amber.

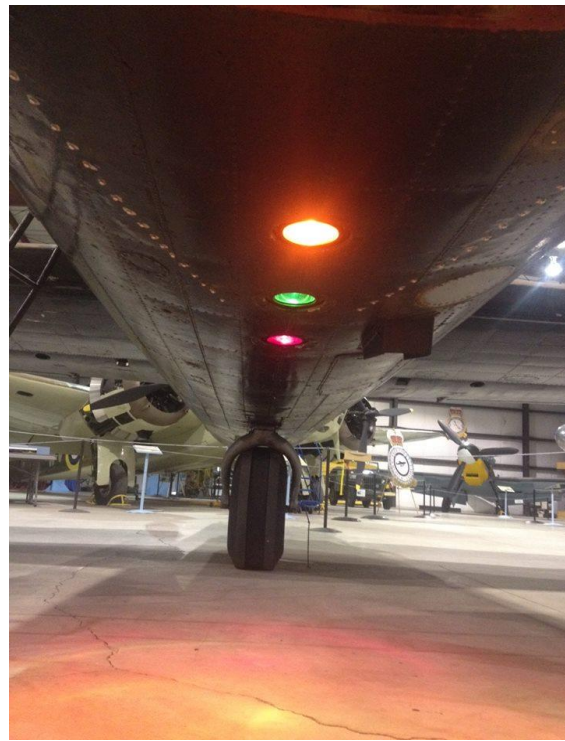
IFF lights operational

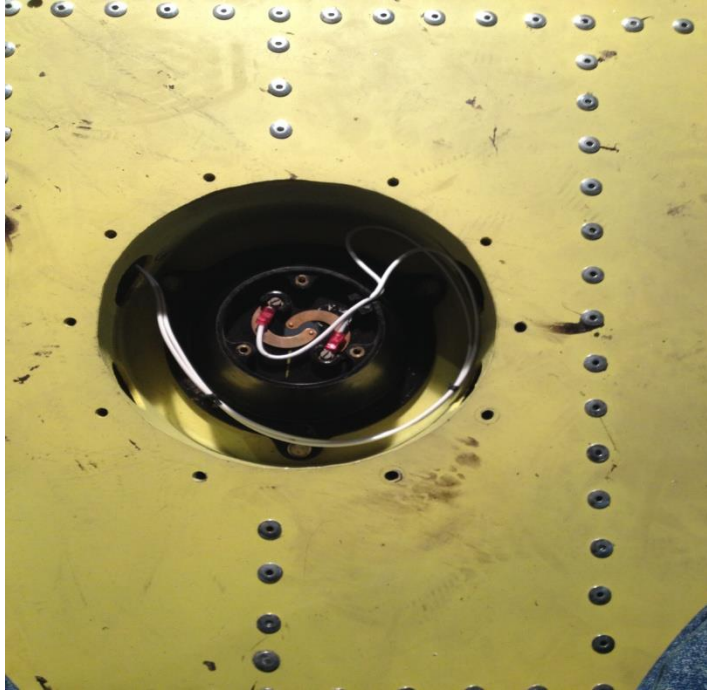
IFF fixture inside view

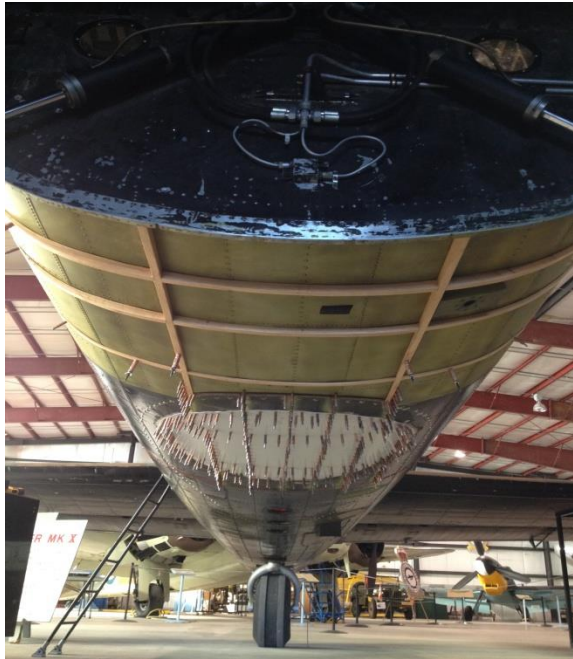
Wooden frame and H2S outer skin in place

The round outer skin piece that covered the H2S opening was secured with solid rivets. Rivnuts were preplaced in the floor to allow the future installation of the H2S fairing.

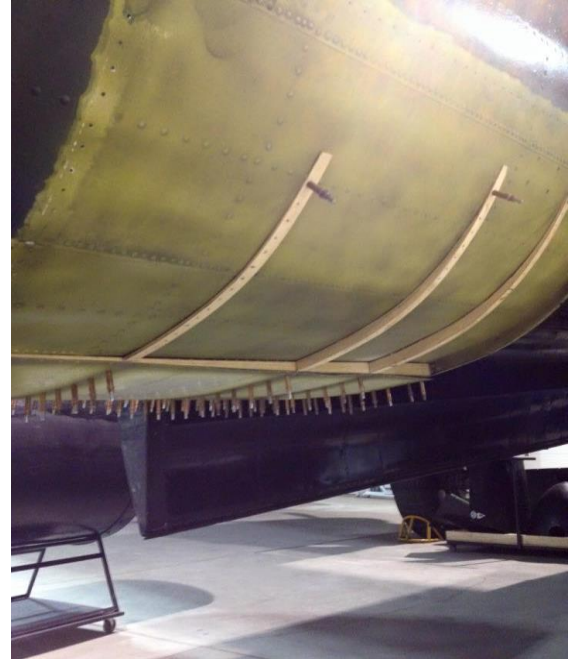
Wooden frame being drilled

The first step and most challenging was to attach the wooden lattice that supports the fairing aft of the bomb bay. To achieve the proper fit Greg used cargo straps that went around the whole fuselage to hold it in place for drilling. The 3 fairing skins had to be attached at the same time as the #8 bolts went through the skin and lattice and floor. The 3 skins were fastened with solid rivets and the #8 bolts.

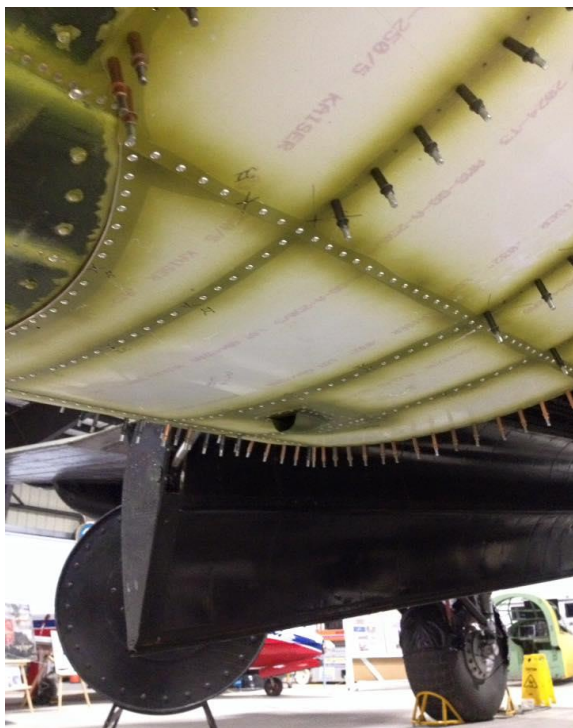
Fairing installation

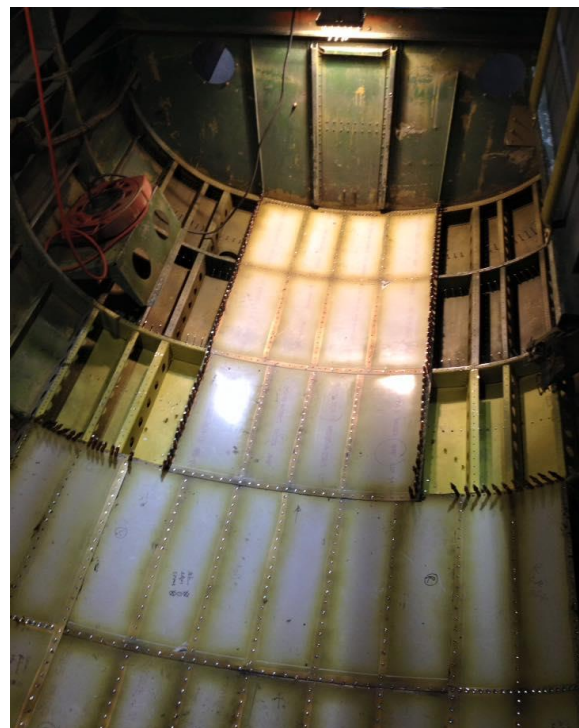
Forward floor section

The remaining assembly involved riveting down 10 individual floor pieces with a combination of 1/8 and 3/16 pull rivets. Proseal was applied to all the intercostals and formers to improve the floor seal and prevent movement.

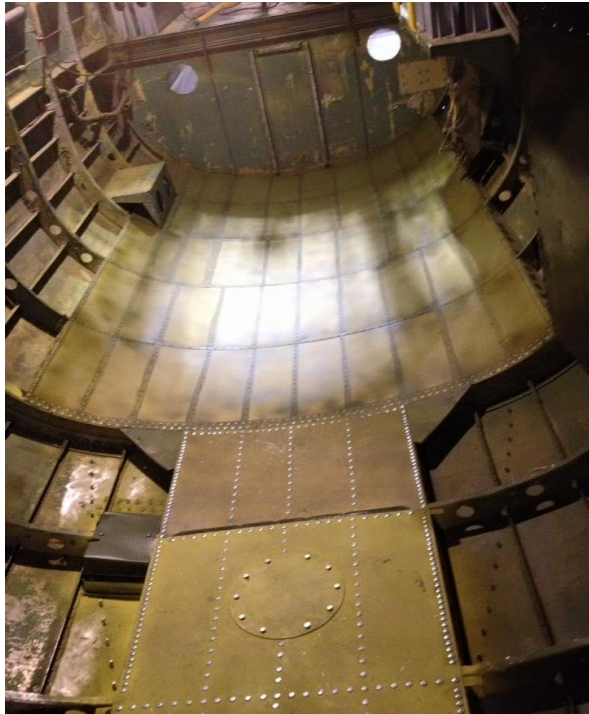
Floor primed

The whole floor was then prepped and primed with zinc phosphate. Once dry, two coats of wing walk were applied to improve the grip for visitors going through the aircraft.

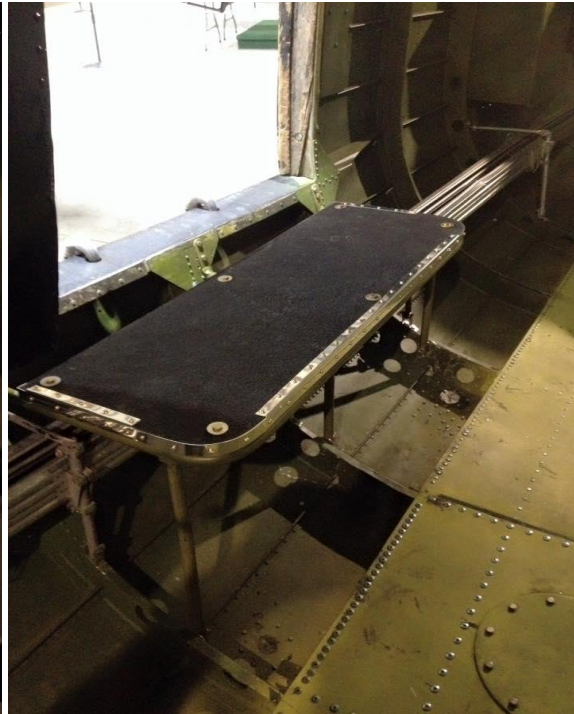
Step over ammo duct

Ben Schwartz fabricated and installed stairs that lead from the tail section to over the bomb bay. A newly fabricated step was also installed at the door to protect the starboard side ammunition duct that runs under the door opening. These steps were all completely built from scratch as no drawings existed for their fabrication.

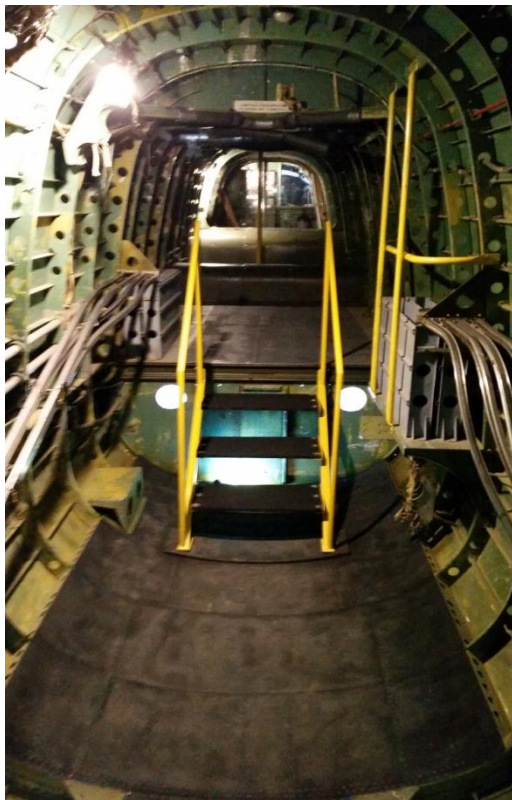
Finished floor with new stairs

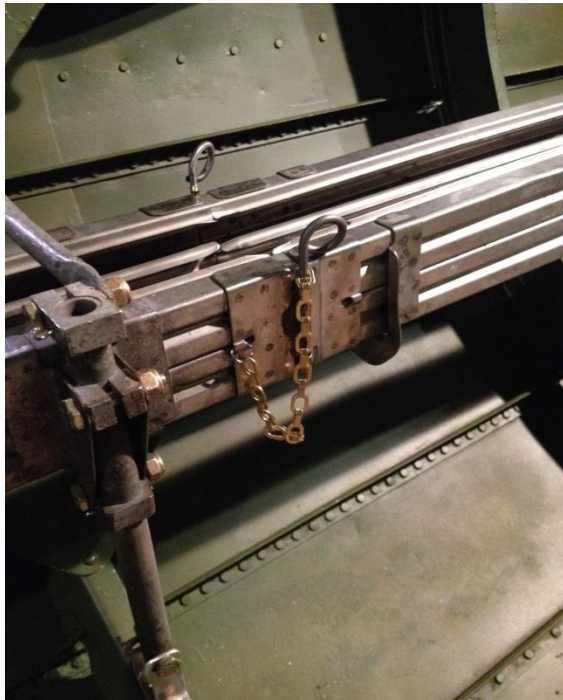
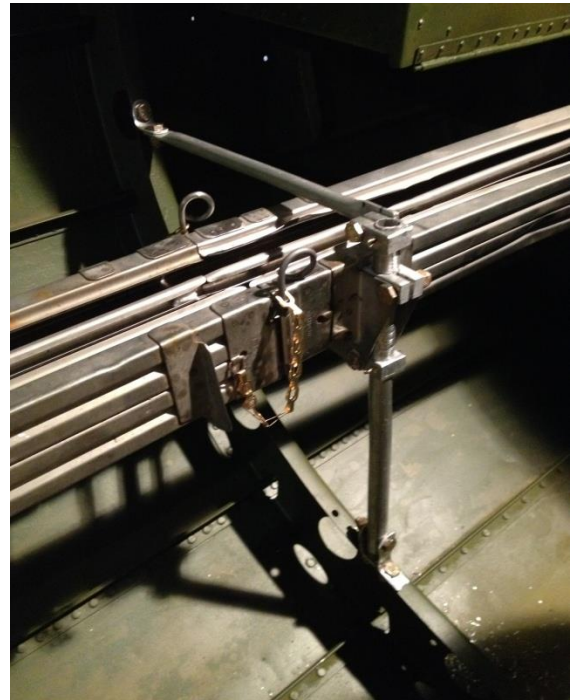
Ammunition duct mounts

I then replaced most of the hardware in the individual pieces as most of these were severely corroded. Dan Hawken and Greg fabricated some of the missing brackets and hardware needed to install the ammunition ducts. I then assembled the pieces in the aircraft and began the arduous task of mounting them using war time plans showing which formers to secure them to.

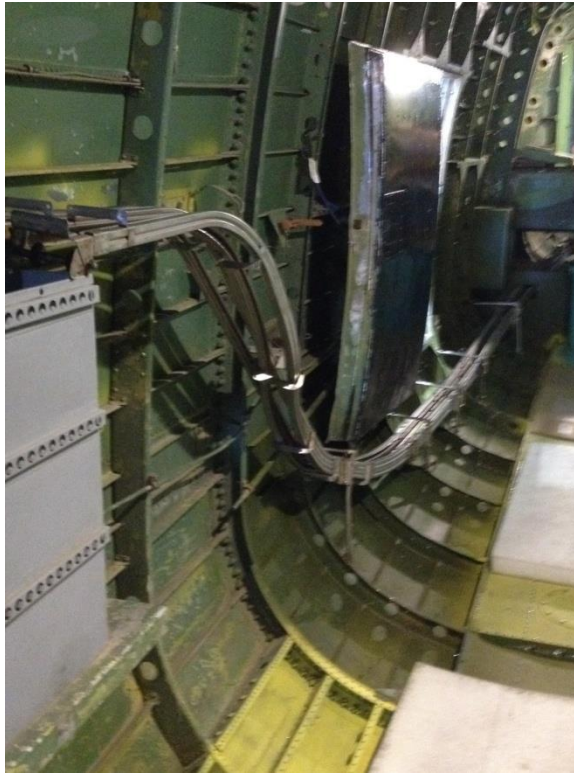
Starboard ammo duct

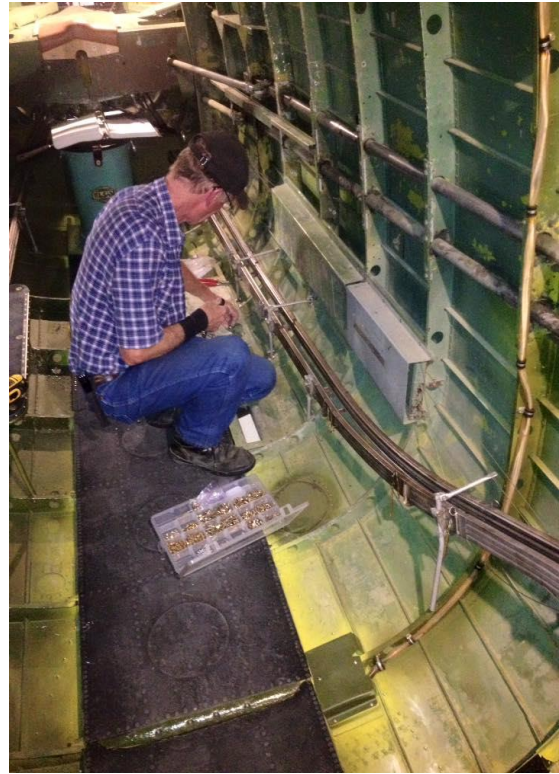
Brian Taylor installing port ammo duct
